FIXING LONELY SHOTS

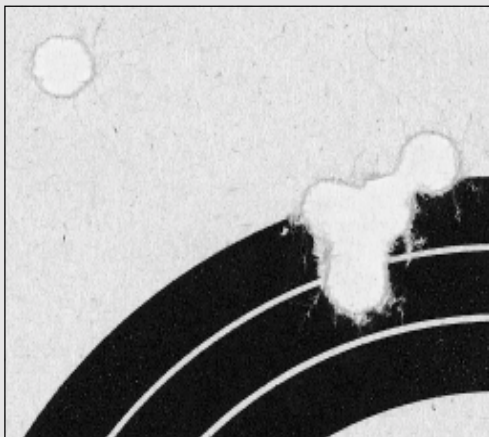
However, we found the opposite to be true in the sandbag test. Without the nosepiece, the gun shot a 10-round group of 3.5 inches. With the nosepiece, the group size ballooned to 4.5 inches. However, the nosepiece group had eight shots inside of 1.44 inches, with three hits touching. The bullet-to-bullet spread on the non-nosepiece group was wider.

So what caused the two fliers on the nosepiece group? Our best guess was that the loading sequence had something to do with it. We shot the groups five rounds at a time, reloading between quintets so that we could maintain a hard front-sight focus without eye fatigue. The

last rounds out of the magazine were the bad shots, so we guessed that diminished pressure applied to the bottom of slide (with the mag empty) changed how elements of the battery fit together.

Above: After installing the Weigand nosepiece, we noticed that fliers ruined some great groups. One possible solution, according to AMU gunsmith David Sams, is to add two set screws beneath the back of the barrel in the frame. These screws force the barrel to align the same way after each shot.

Eventually, he solved the problem by adding two set screws beneath the back of the barrel in the frame. These screws, drilled at an angle into the frame, forced the barrel to align exactly the same way after each shot. “That may have been one of the most subtle, but most important advancements in the gun’s accuracy,” he said.
