Shooter Alert: Unplanned Discharge

During our testing of the Christensen Arms Carbon One rifle, we experienced problems with an “unplanned discharge.”

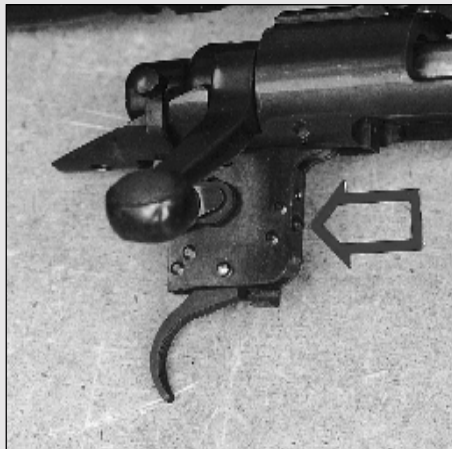
Above: The adjustable trigger on the Carbon One would discharge in certain situations. We found a screw on the trigger that was backed out too much, which allowed the sear to fall too easily. However, we don’t know if the loaner gun came from the factory like that or if someone had improperly adjusted the trigger. Christensen said the trigger is safe to operate as it comes from the factory.

In fact, because the trigger pull was below the advertised 1.5 pounds when we took delivery of the rifle, we suspected that an incompetent person may have attempted to adjust the trigger. Upon disassembling the gun we found that the trigger-adjustment screw was indeed backed out. Apparently, it was never treated with a thread locker. Thus, we couldn’t determine if the adjustment was done intentionally or if it occurred due to vibration during use.

We readjusted the trigger to break at 1 3/4 pounds, but that did not cure the problem. A Christensen representative said that the company’s guns and triggers are safe unless they’re tampered with, and that we should return the test Carbon One to the factory.

Since we deemed the rifle to be unsafe to shoot at that point, we shipped it back to Christensen Arms to be checked out and repaired. In a future issue, we plan to check out the Carbon One’s trigger in a retail-ready sample to assess its safety performance.

Our experience also serves as a reminder that any precision trigger operates under minimum tolerances and can quickly get out of adjustment, causing a dangerous situation. All adjustments should be locked in place with a thread locker, and shooters should never break the most basic safety rule—always point the muzzle in a safe direction.
